## Property Inspection Report

8888 NW 3333rd Ct, Coral Springs, FL 33071

## J.R. Inspection Services

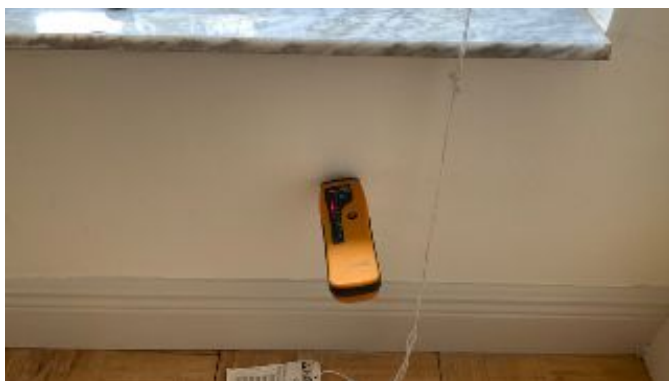
**Water Penetration***Inspected***Deficiency***1. Active water penetration found under master bedroom right window (because window does not close).**Areas were tested with moisture meter and were found Wet. Since the exact cause of this condition cannot be ascertained by only a visual inspection, consult licensed waterproofing contractor.****Estimated Price: 150.00***

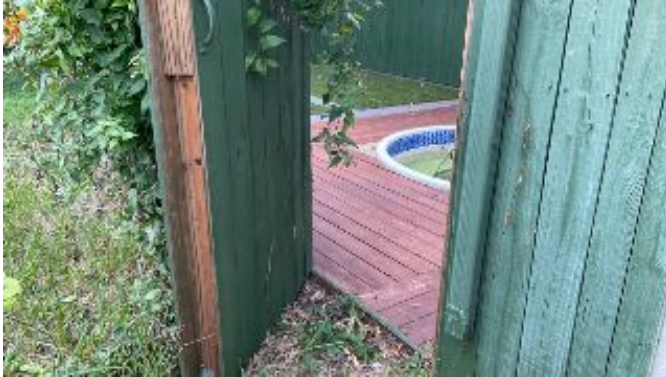
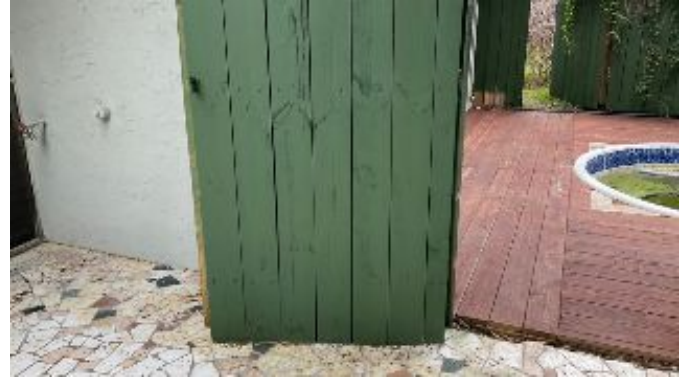
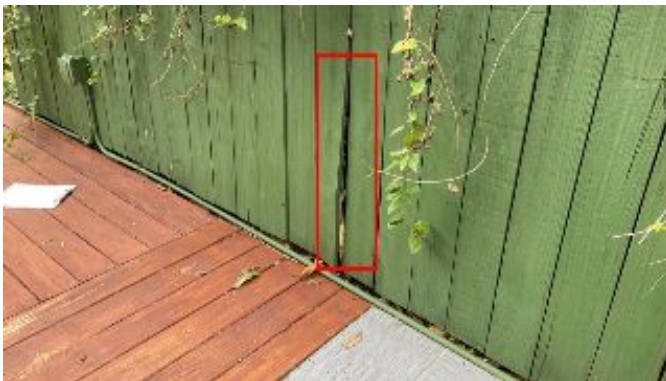
1. Both Wood gates around spa are binding (dragging on ground).
2. Wood slat damaged because of hedges at spa area (left side)

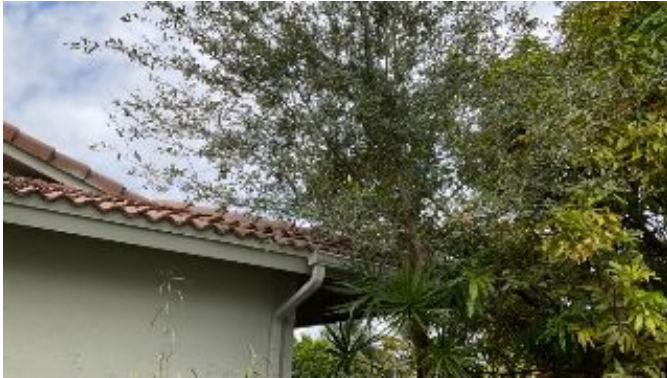
1. Trim tree limbs/hedges over hanging roof.

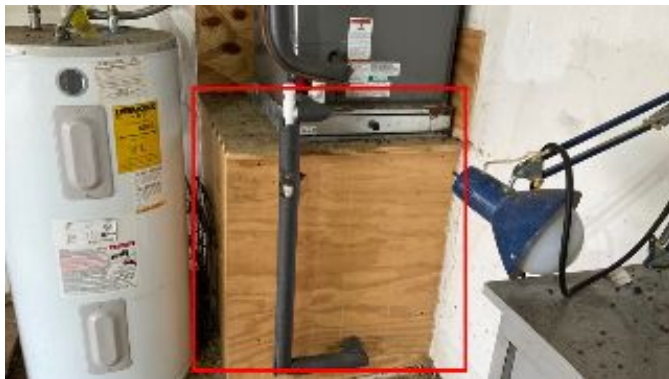
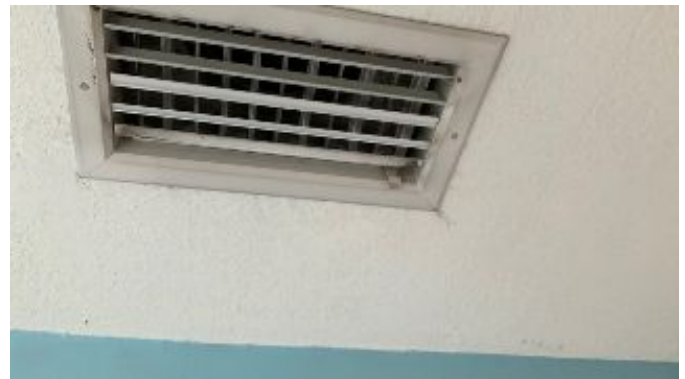
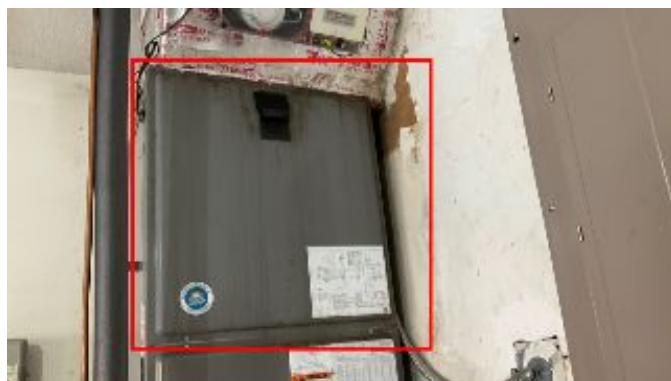
1. The entire a/c return box is unfinished wood. Must be painted with an antimicrobial paint per the Mechanical Florida Building Code.
2. Dust/dirt/mold found around several a/c register grills. Have all a/c register grills and ducts cleaned and sanitized.
3. Clean surface mold off of air handler
4. Minor dust/dirt on evaporator coil

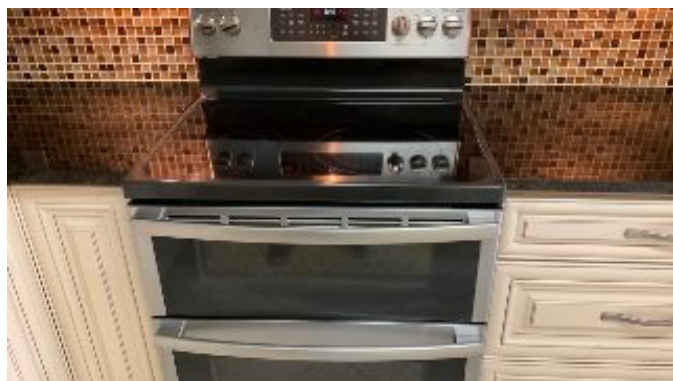
1. Anti Tip bracket is missing for stove. They became a requirement on June 1991 by UL standard and the Florida Building Code which states "appliances and equipment shall be installed in accordance with the manufacturer's installation instructions. The purpose of the bracket is to provide an additional margin of safety when excessive force or weight is applied to the open door.

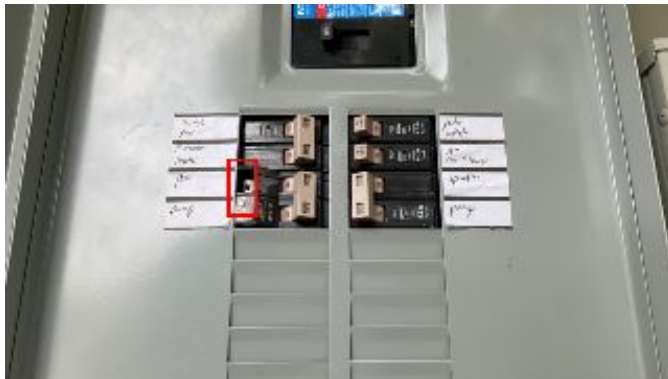
1. Part of 20 amp breaker damaged at main exterior panel box

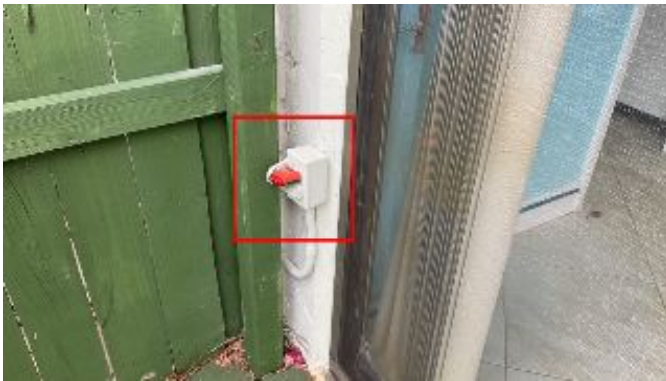
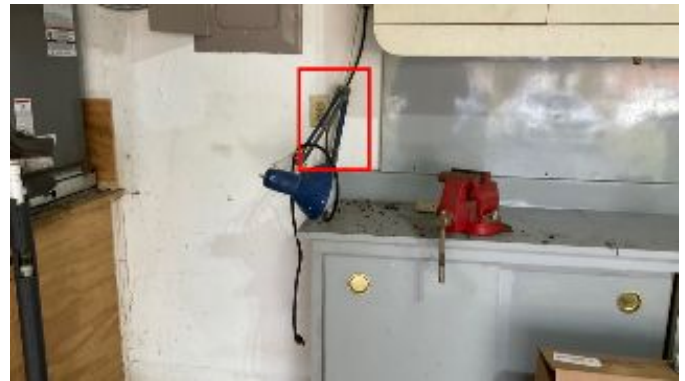
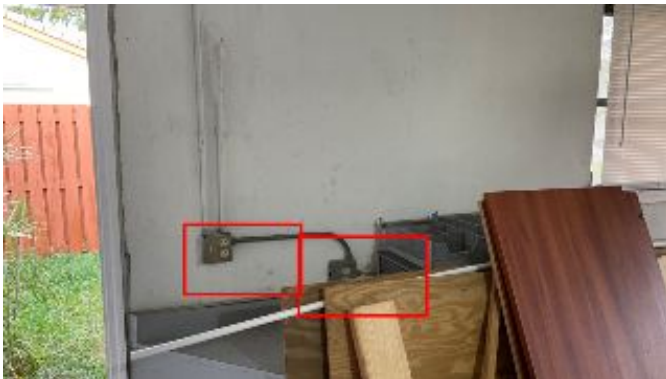
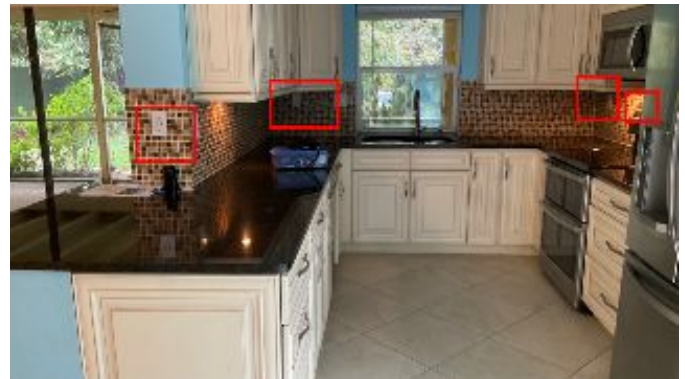
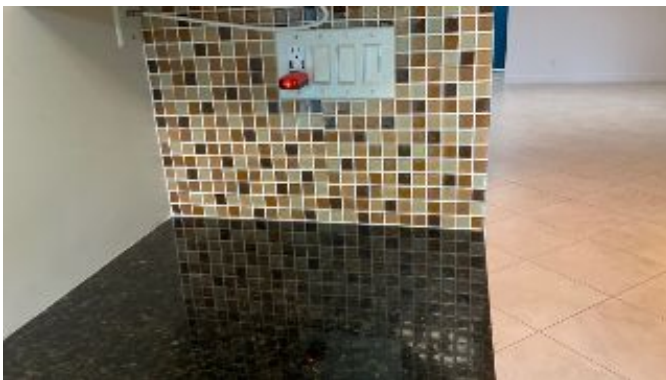
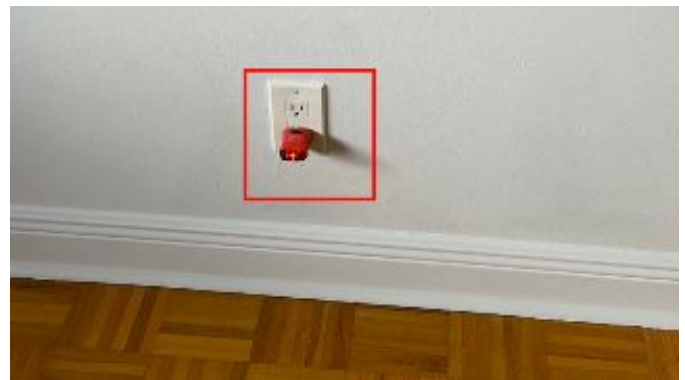
1. Outlets at the following locations failed to respond to Trip Fault Test for GFCI Protection at:
  - a) exterior outlet left of kitchen glass slider
  - b) all 4 garage outlets
  - c) all kitchen counter top outlets including desk outlet which has an open/weak ground connection
2. Outlet in middle bedroom (south wall) has a weak/open ground connection

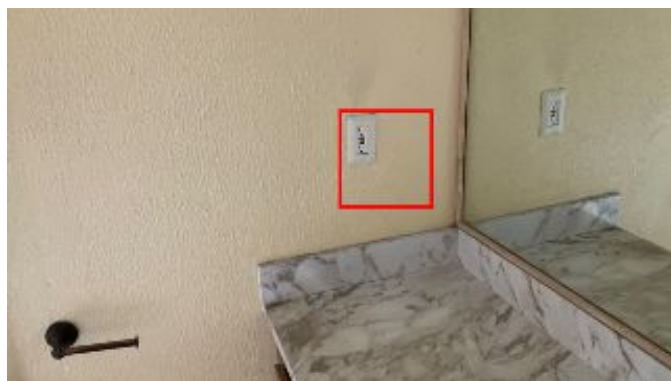
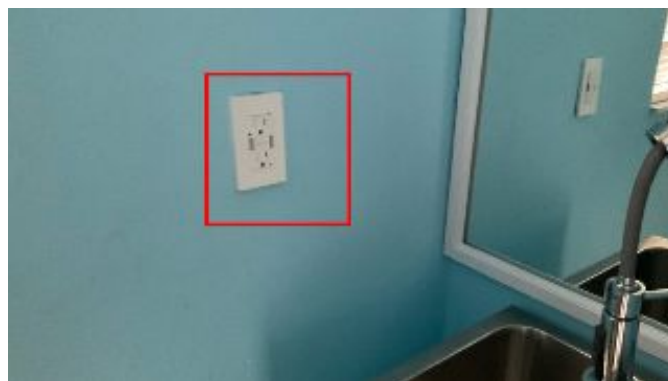
1. Outlet control GFCI not working independently. It trips the GFCI control at the garage panel box:

- a) powder bath
- b) master bath

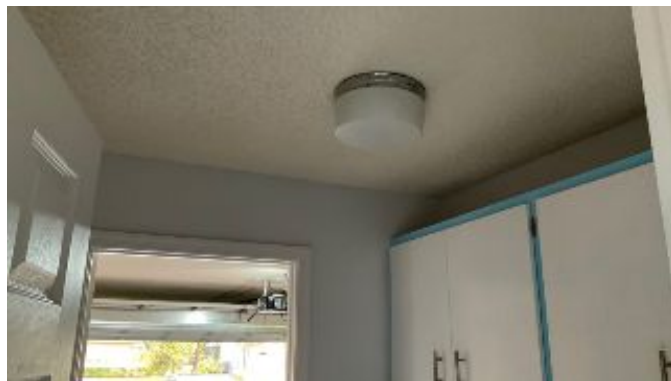
1. 3 way switch not operating independently for laundry room light

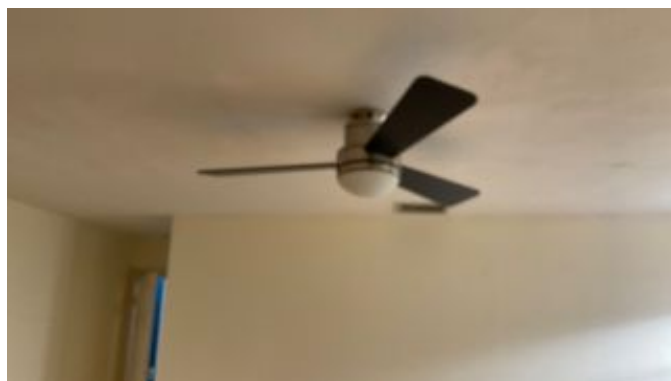
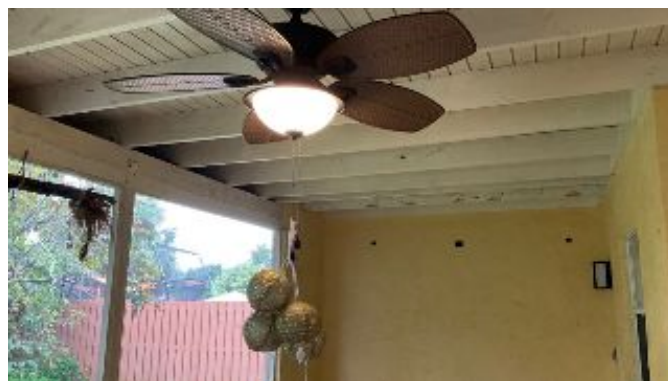
1. Could not find remote for master bedroom ceiling fan
2. Pull chain for patio fan needs repair.

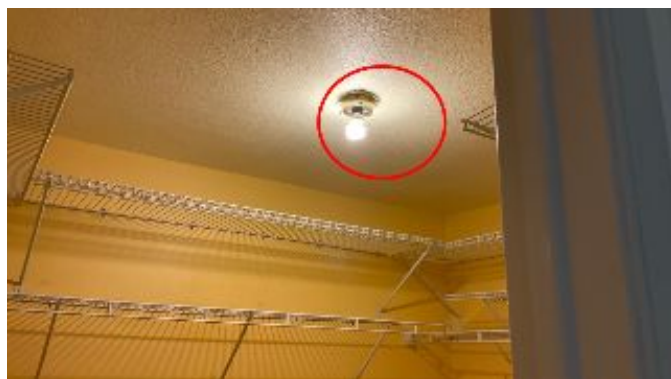
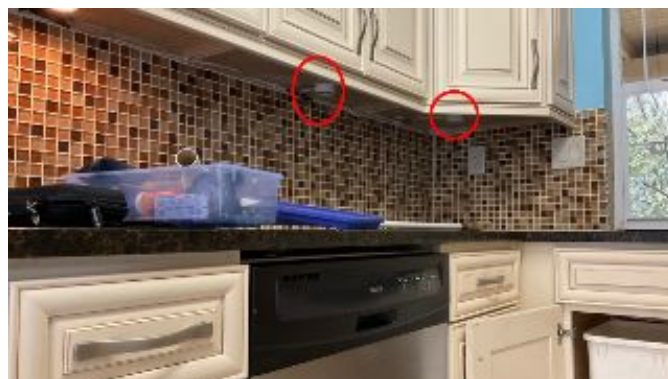
1. Protective lens cover/globe missing at master bedroom closet.
2. Several under mount kitchen lights out and exposed wires

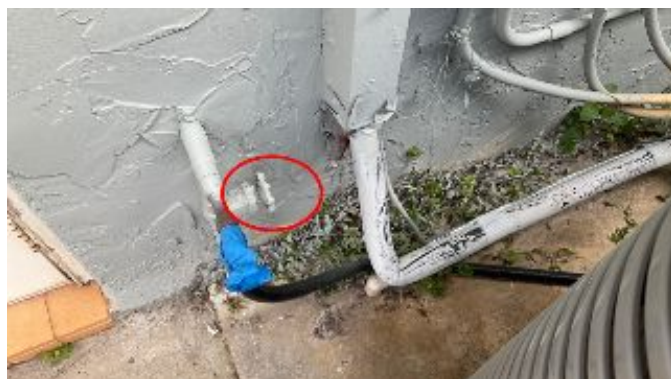
1. The old gate valve handle needs to be replaced to ball valve lever handle.

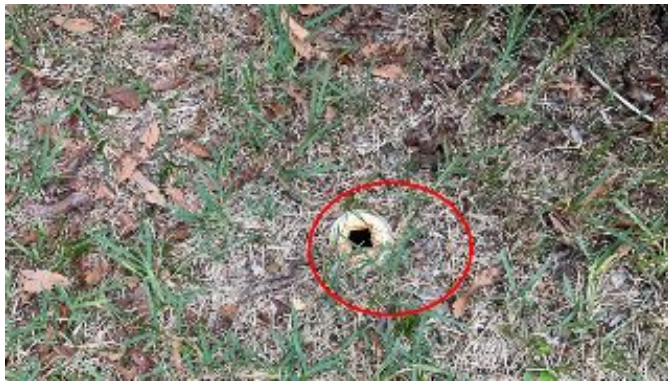
1. Cover broken front yard.

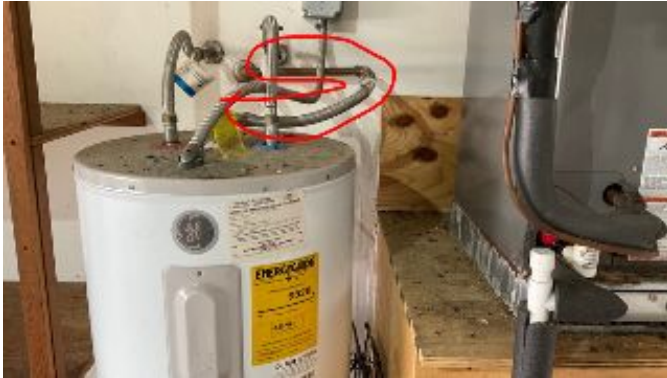
1. Pressure release discharge pipe improperly installed, MUST pitch downward for free draining.

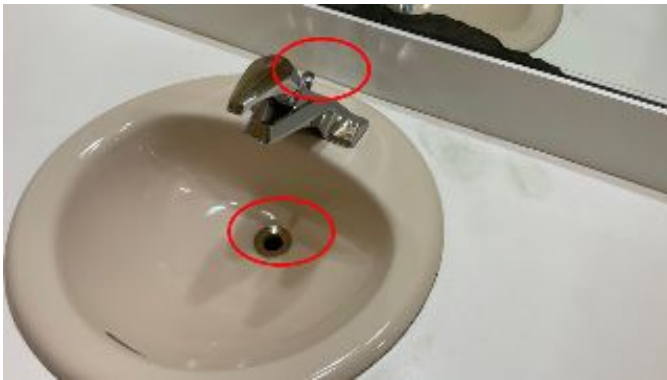
1. Drain pop up missing at hall bath sink

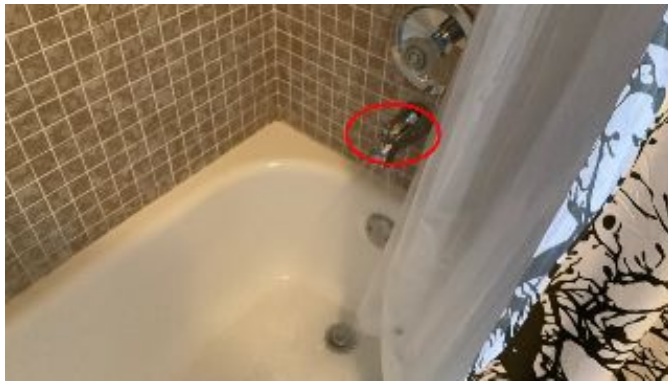
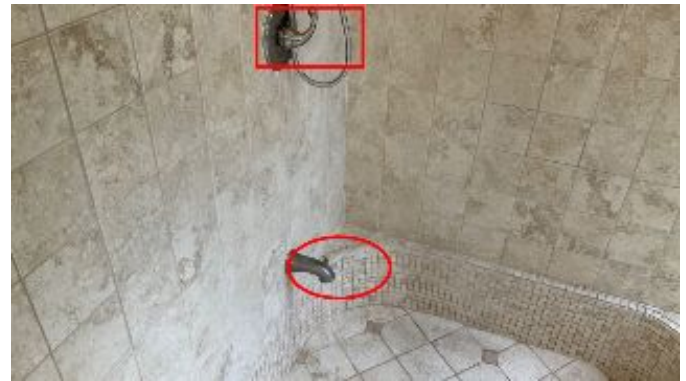
1. Shower Diverter not fully engaging at hall bath tub and master bath shower

2. Handel loose, too much play at master bath shower.

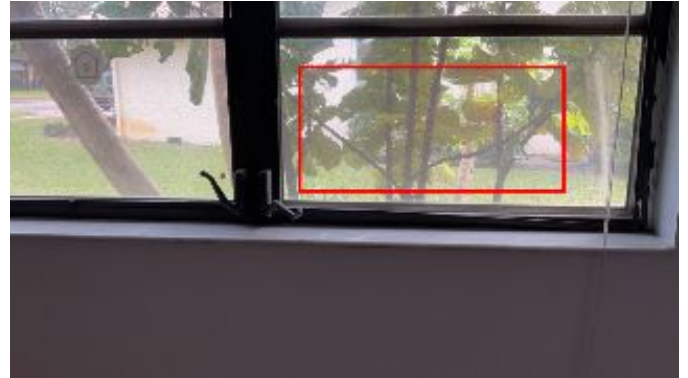
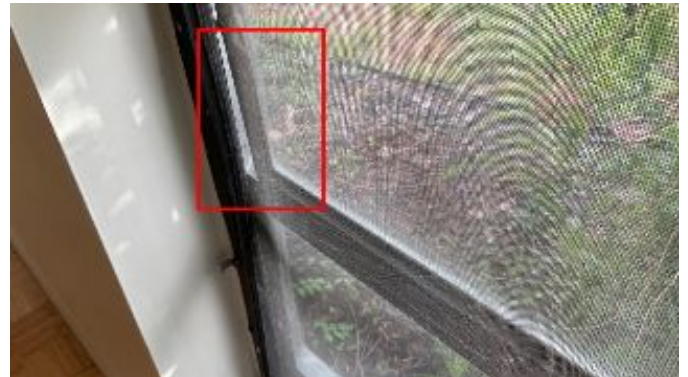
- 1. Defective window balancers at hall bath window.*
- 2. Right awning window at middle bedroom sticks*
- 3. Defective window operator master bedroom left window*

4. Section of awning window not locking master bedroom right window and garage window

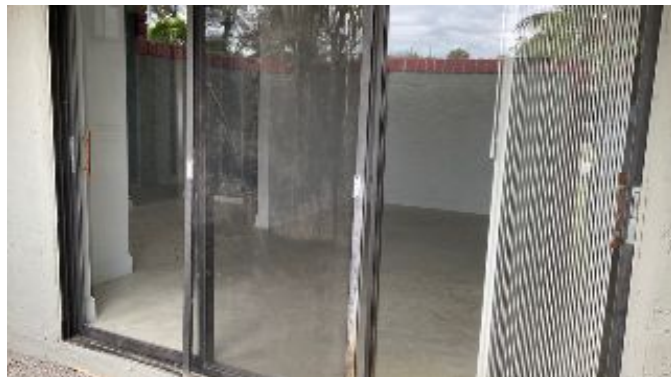
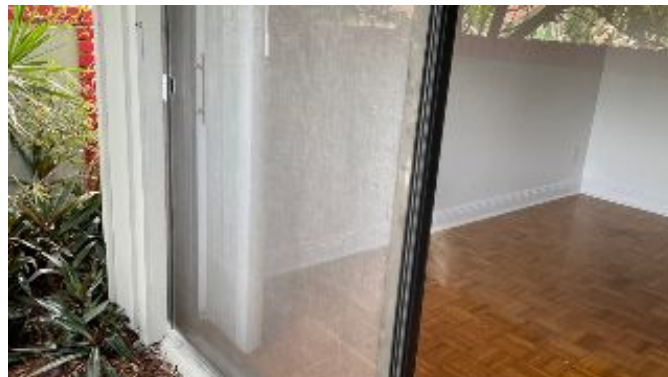
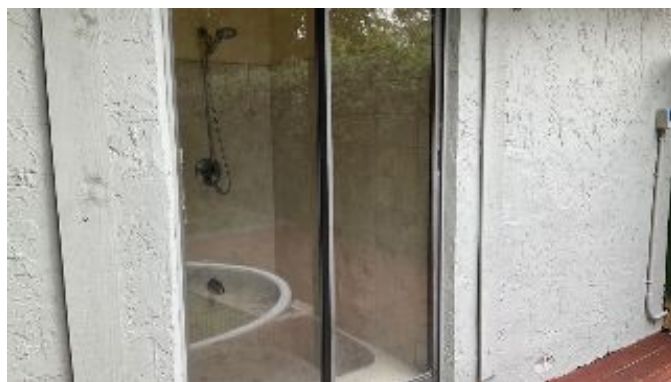
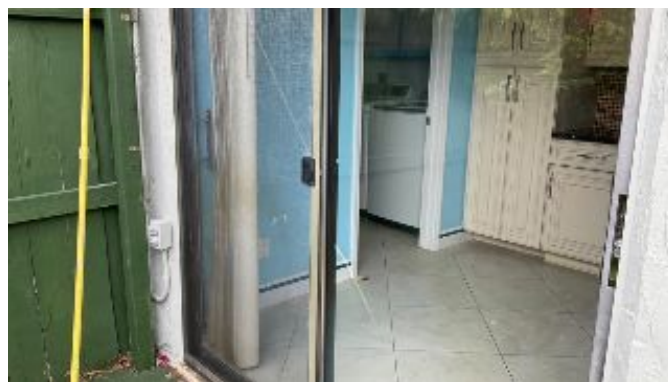
1. Screen sliders off track/binding/defective hardware/torn screening at:

- a) front
- b) front guest bedroom

c) kitchen

2. Missing screen slider master bath.

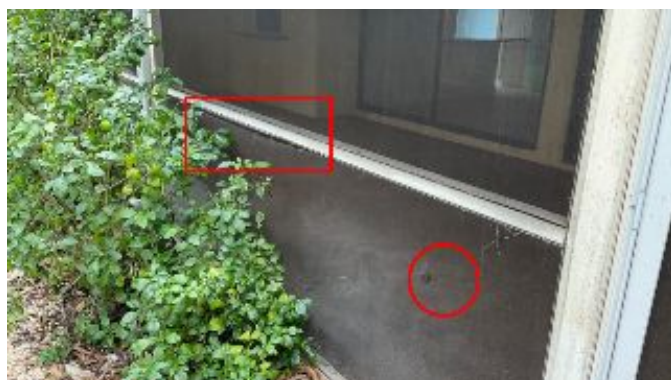
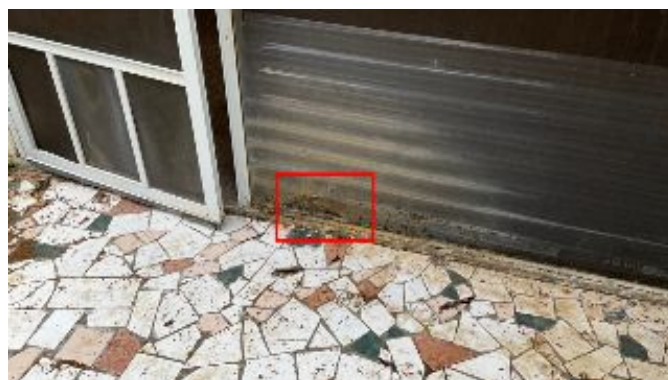
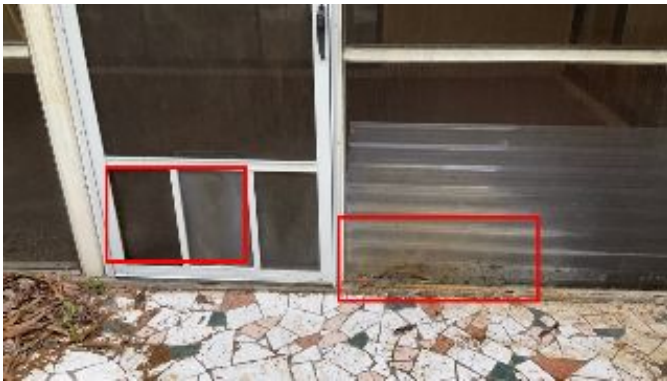
1. Torn screen panels at patio, repairman to check all screens on patio and replace screening accordingly.

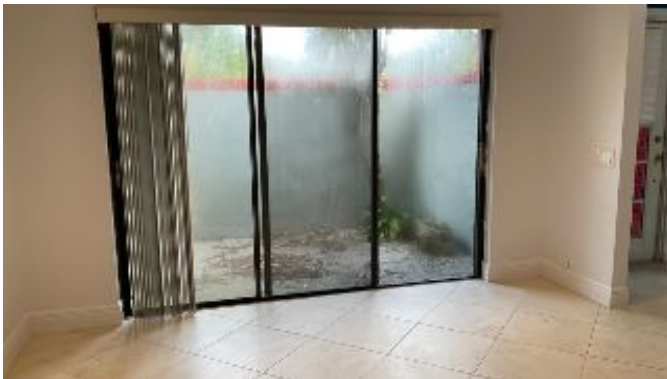
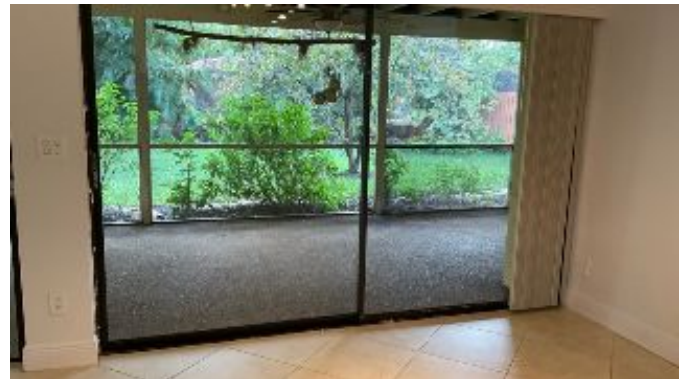
1. Front living room glass slider and family room right glass slider are binding.

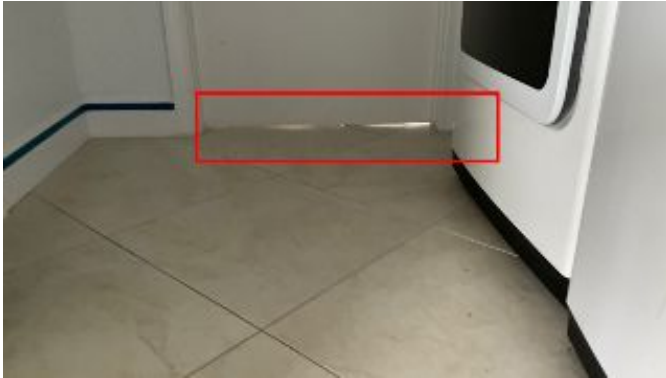
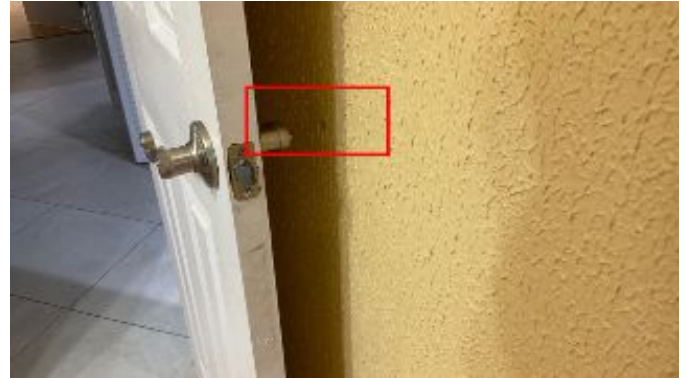
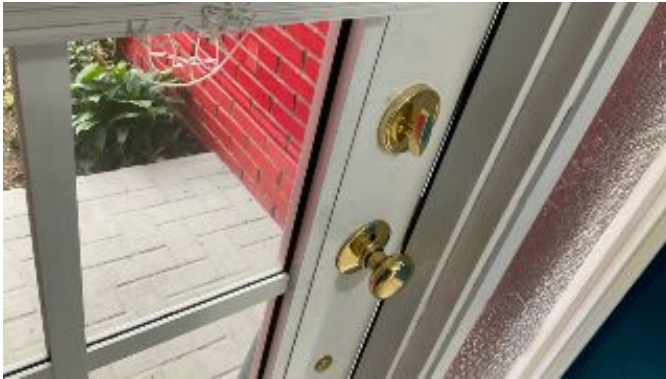
1. Daylight seen at door from laundry room to garage, losing air.

2. Doorstop missing at both hall bath doors

3. Adjust striker plate for front door (too much play)

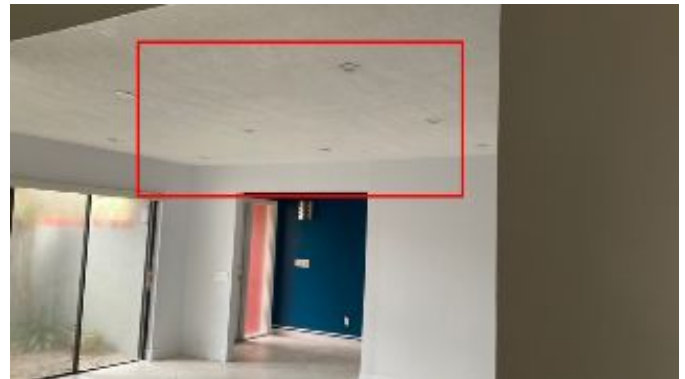
1. Ceiling damaged master bedroom.
2. Living room ceiling has a belly (dip in ceiling) does not appear to be properly attached.

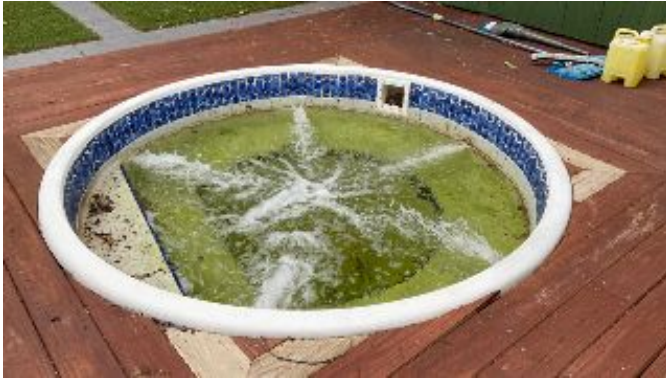
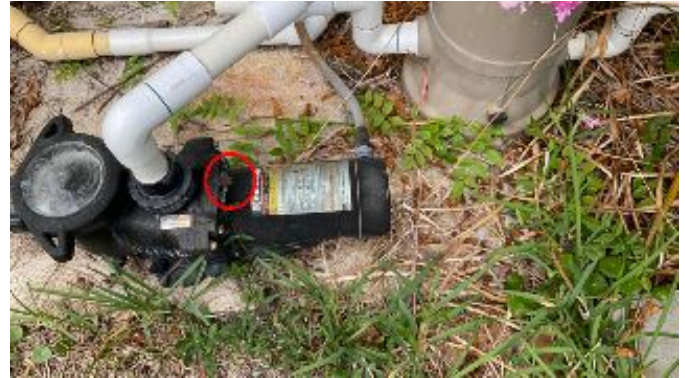
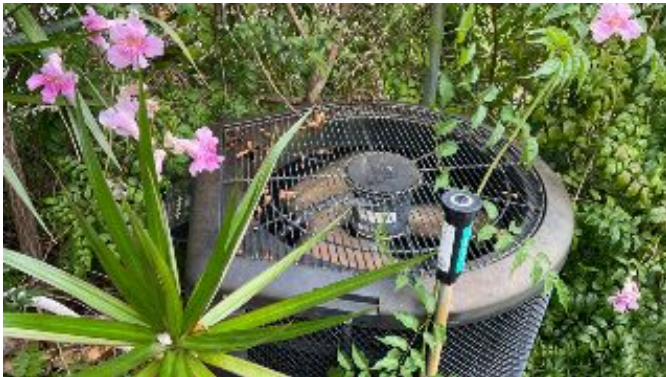
*a) water level low (from a leak or evaporation). An accurate test for damage and/or leaking cannot be done without continual*

*observance of the pool. Consult pool service contractor. **Recommend leak test be performed \$225.00***

*b) water dirty, chemicals are off*

*c) missing bond wire for motor*

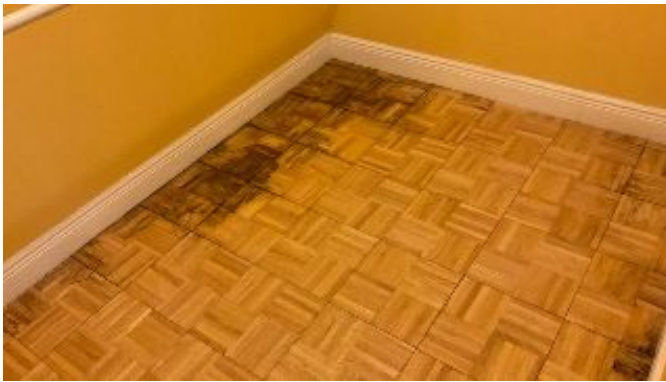
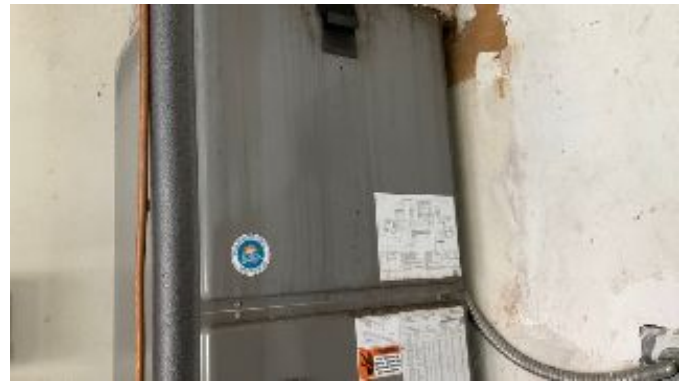
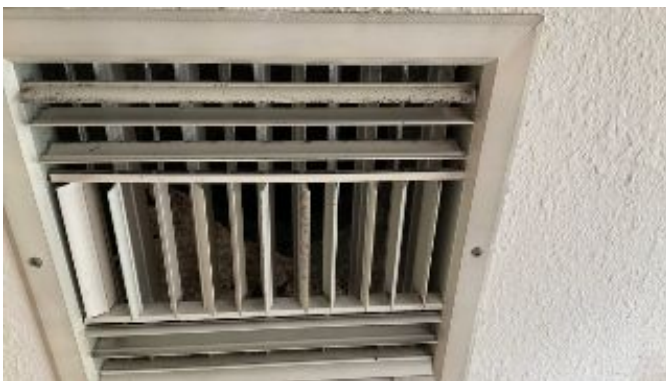
*1. Inspector observed suspect mold at:*

*a) flooring master bedroom closet, although it tested dry once flooring is removed a water test must be done to verify this is not active.*

*b) several a/c register grills/ducts*

*c) cover of air handler*

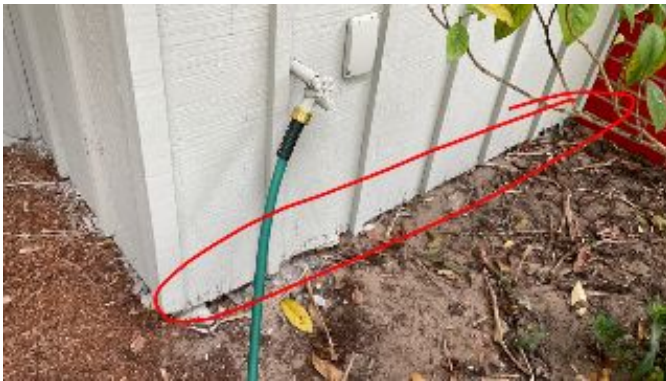
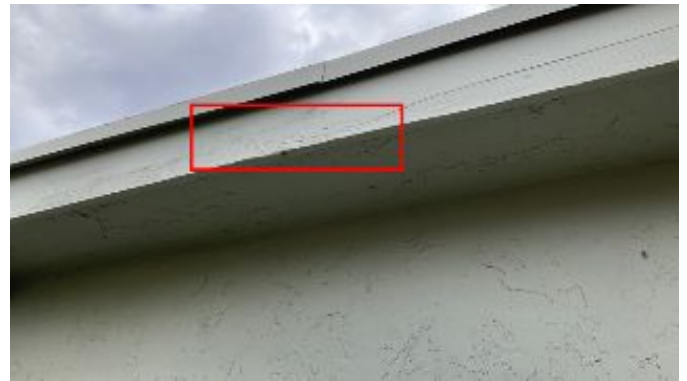
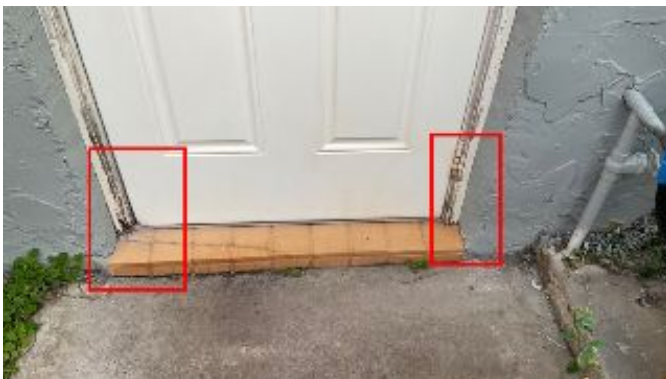
*1 Wood decaying fungi found at:*

*a) wood siding front of house*

**Wood Decaying Fungi (must be attached to WDO DACS 13645 report)***Inspected***(continued)***b) fascia west side of patio (right side of house)**c) frame areas of side garage door*

**\*\*\***All wood damage must be replaced with wood to pass reinspection. Wood fillers are a temporary solution. When inspected, if

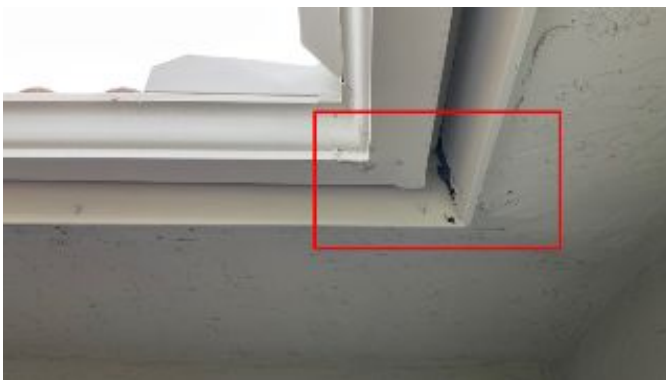
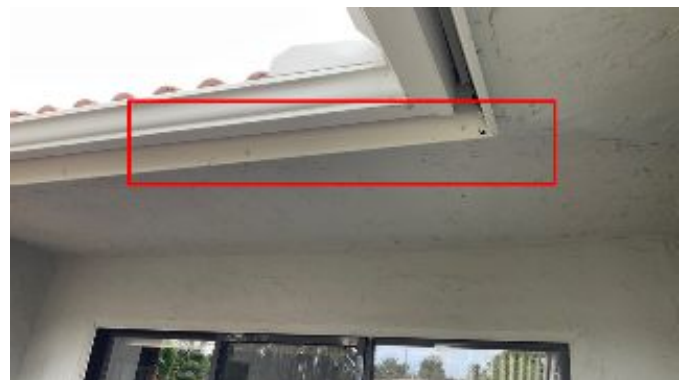
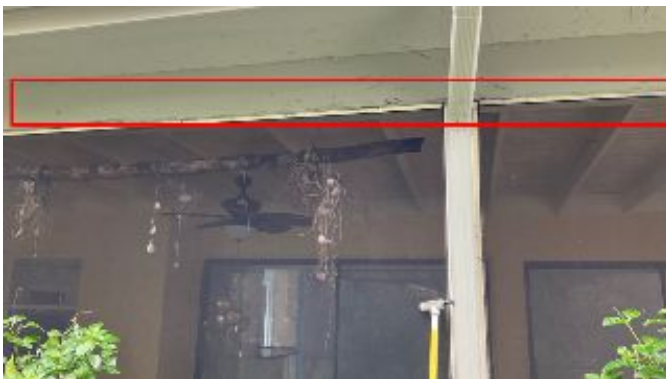
1. Drywood termite pellets and damage found at

a) fascia front of house

b) entire beam over patio rear of house

2. Requires treatment/fumigation unless property is under an active guarantee. Pest Control Company providing treatment must provide a clear WDO report. Estimated cost for drywood termite treatment.

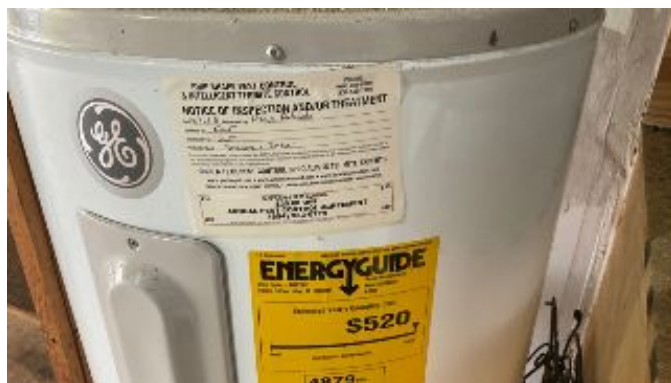
Inspector observed sticker on water heater stating house has been treated for drywood termites. Buyer to get copies of all treating and guarantee documents.

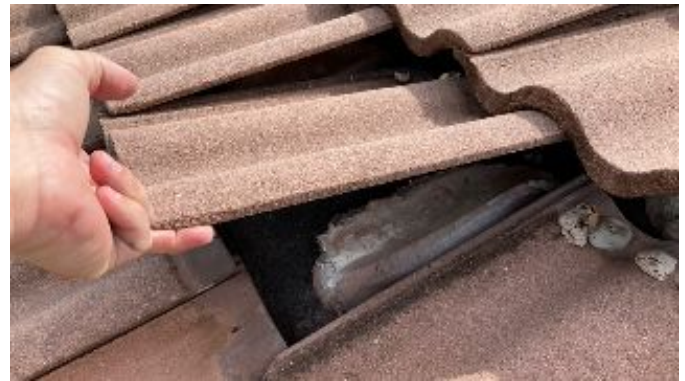
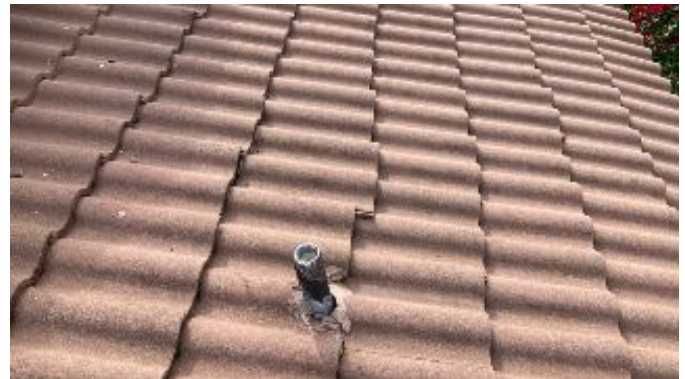
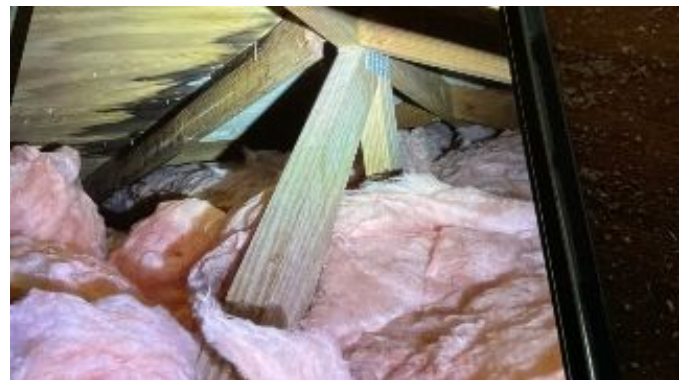
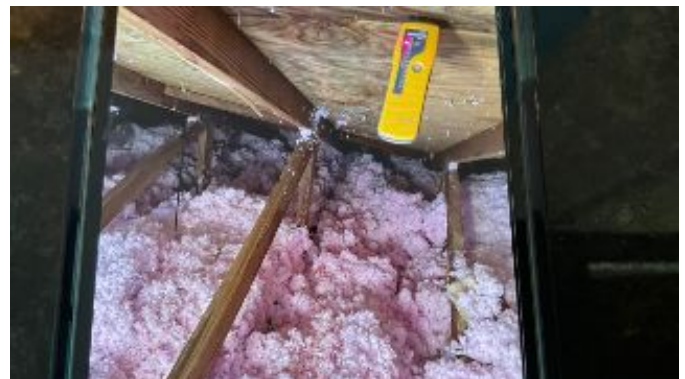
1. Active roof leak with fascia and sheathing damage left side of house above electrical panel box.
2. Active roof leak right of side garage door, seen from attic
3. Active roof leak above master bedroom door (stains seen in attic)
4. Stains on family room ceilings
5. 100% of the tile roof is loose, not secured, tiles have slipped. Do to this condition coupled with the age of this roof (29 years old), this roof requires complete replacement (this is a cement on system).

\*\*\*Roofer to replace all rotted wood

\*\*\*roofer to replace gutters

\*\*\*Flat roof is 8 years old and should be replaced at the same time

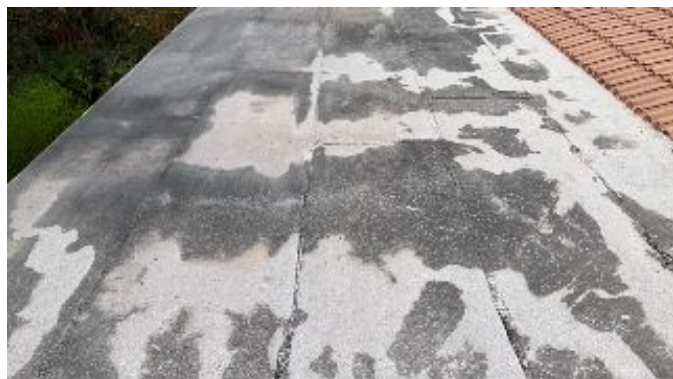
**Secondary Roof (continued)***Inspected***Information***View of flat roof*

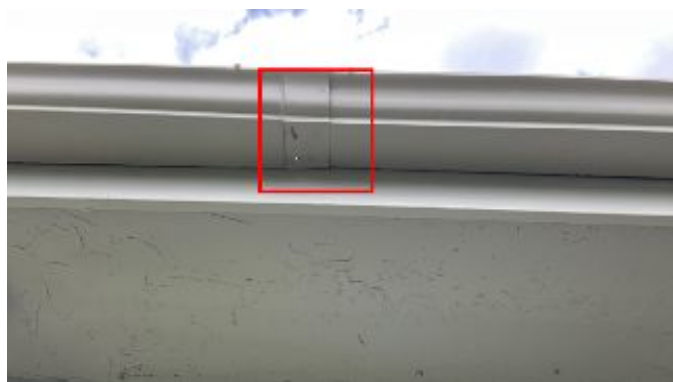
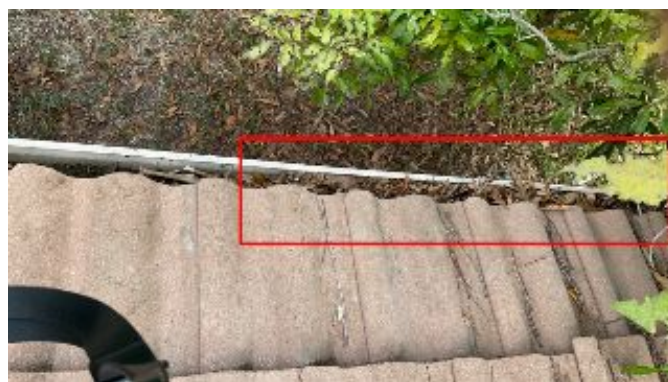
**Roof Deck & Rafters***Inspected*Structural Deck: *Plywood*Trusses / Rafters: *2" x 4"***Gutters and Downspouts***Inspected***Deficiency***1. Gutters:**a) damaged rear of house at seams**b) filled with debris****Estimated Price: 200.00***
