## Property Inspection Report

8888 NW 3333rd Ct, Coral Springs, FL 33071

## J.R. Inspection Services

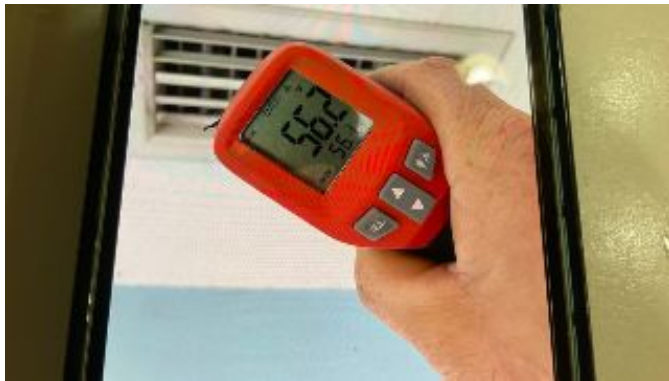
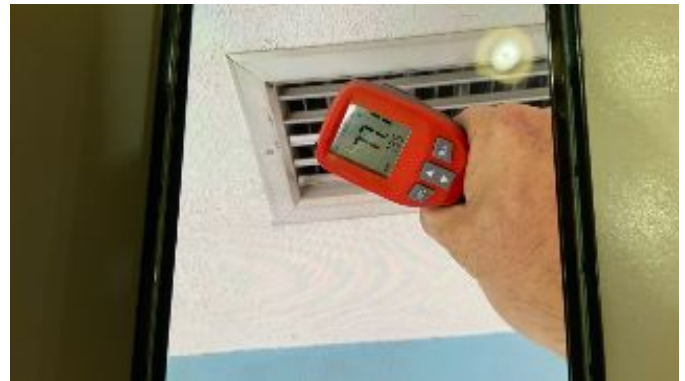
**Operation of A/C***Inspected***Deficiency**

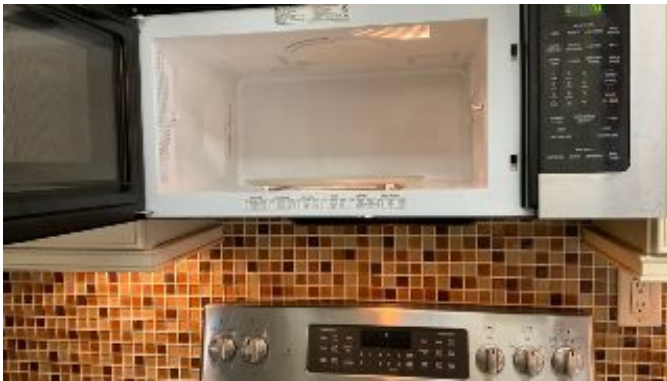
**Deficiency**

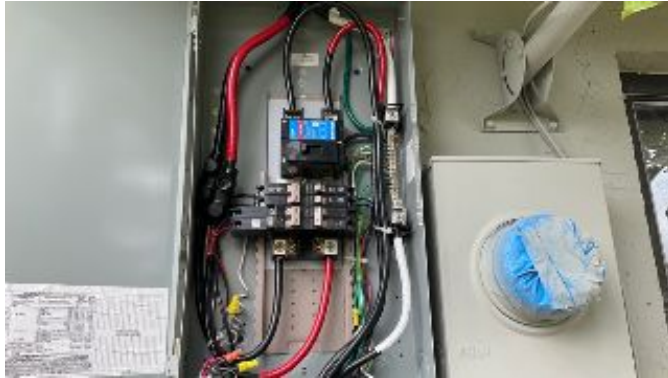
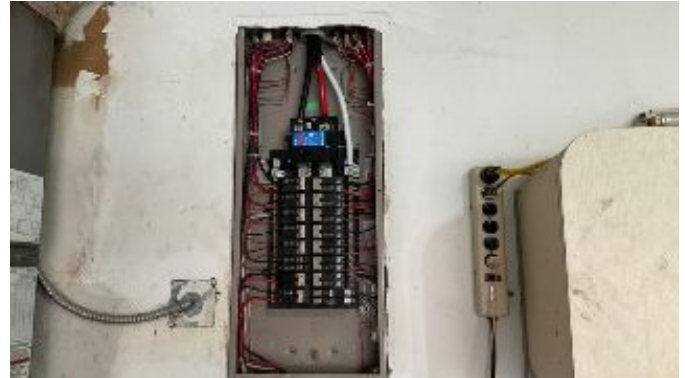
**Deficiency**

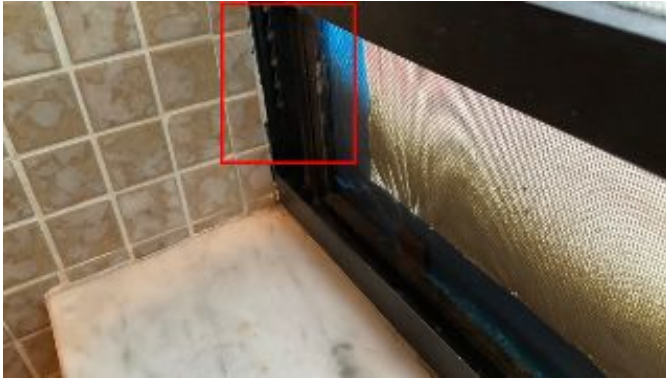
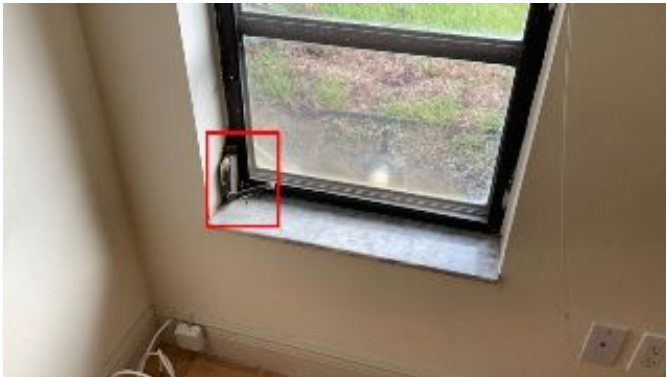
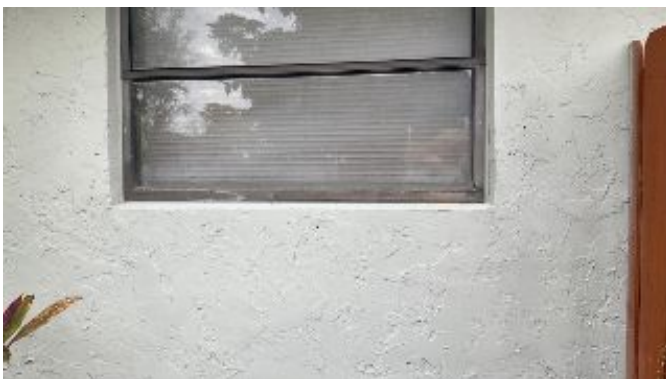
*Inspected*
